IMPACT RESISTANCE OF
COMPOSITE FAN BLADES

E. J. PREMONT
K. R. STUBENRAUCH

PRATT & WHITNEY AIRCRAFT
DIVISION OF UNITED AIRCRAFT CORPORATION

1. Report No. NASA CR-134515		2. Government Accession No.		3. Recipient's Catalog No.	
4. Title and Subtitle Impact Resistance of Composite Fan Blades Final Report				5. Report Date May 1973

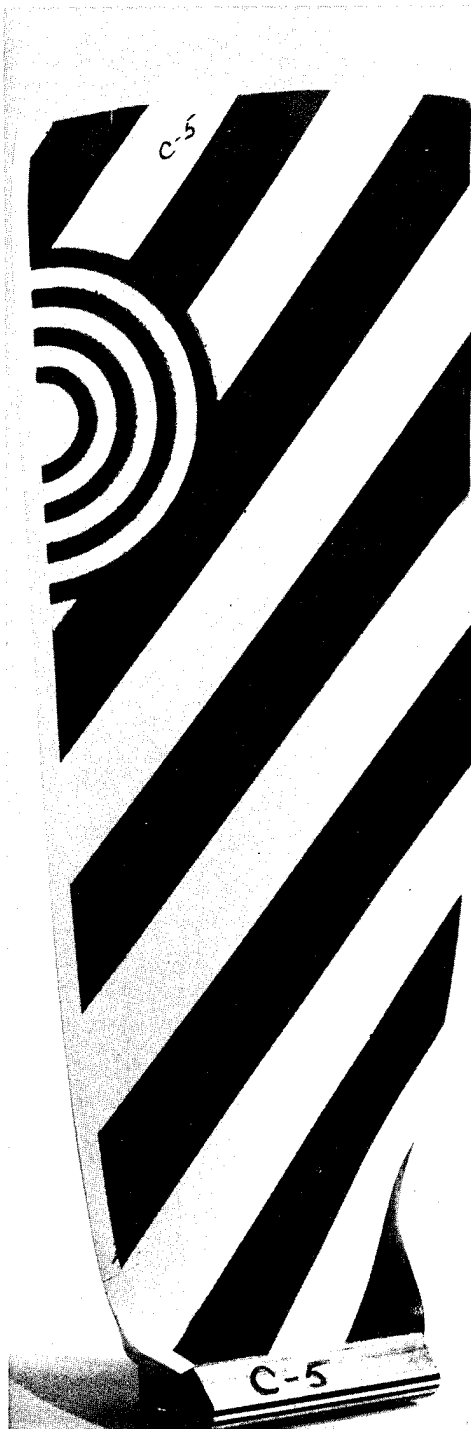
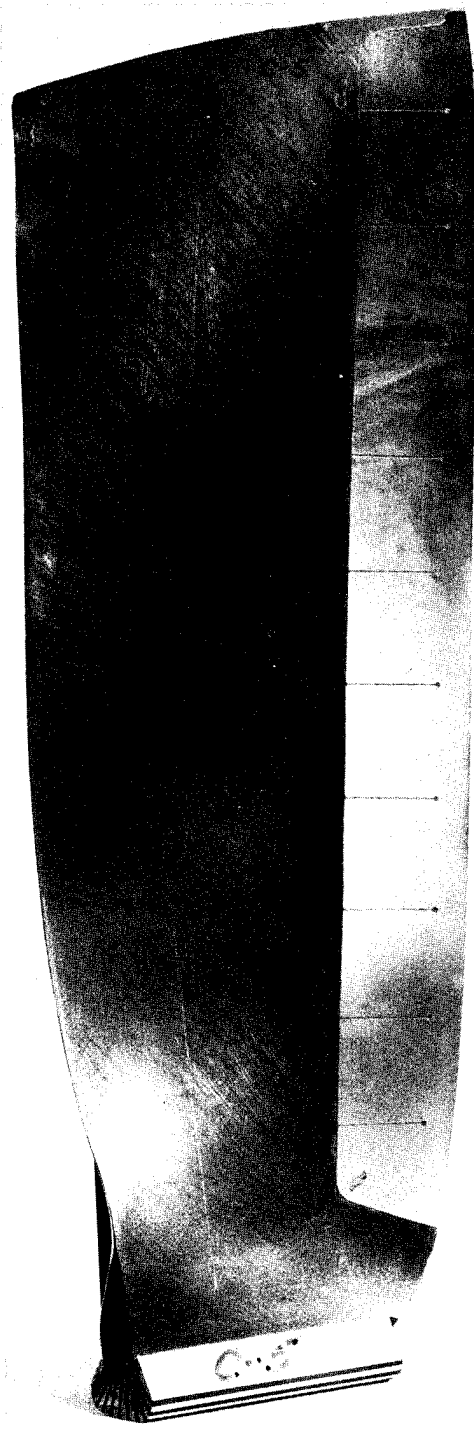
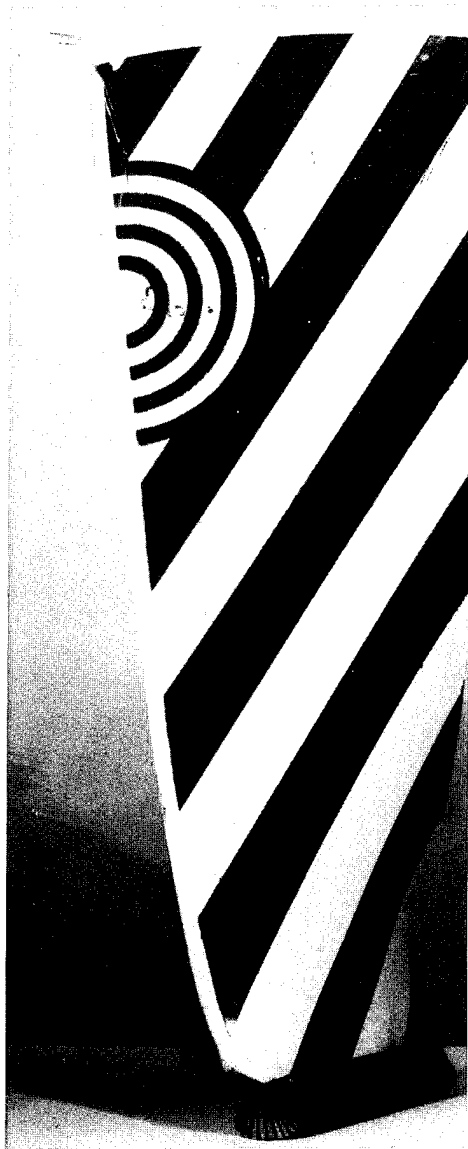
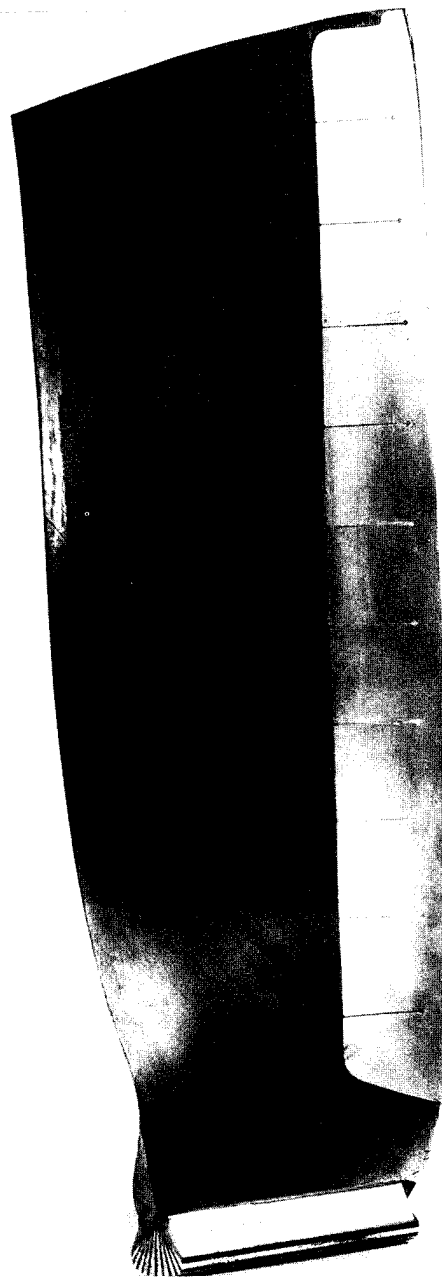
Figure 50 Graphite/Epoxy Blade C-5 Following Impact with 75g Starling

Blade C-5 and B-5 were impacted with 75g (2.6 oz) and 80 g (2.9 oz) starlings, respectively. The 40g (1.4 oz) slice taken by C-5 and the 45g (1.6 oz) slice cut by B-5 caused only slight damage in each case. The damage which occurred seems to be related to blade fabrication problems. Both blades are pictured in Figures 50 and 51 respectively.

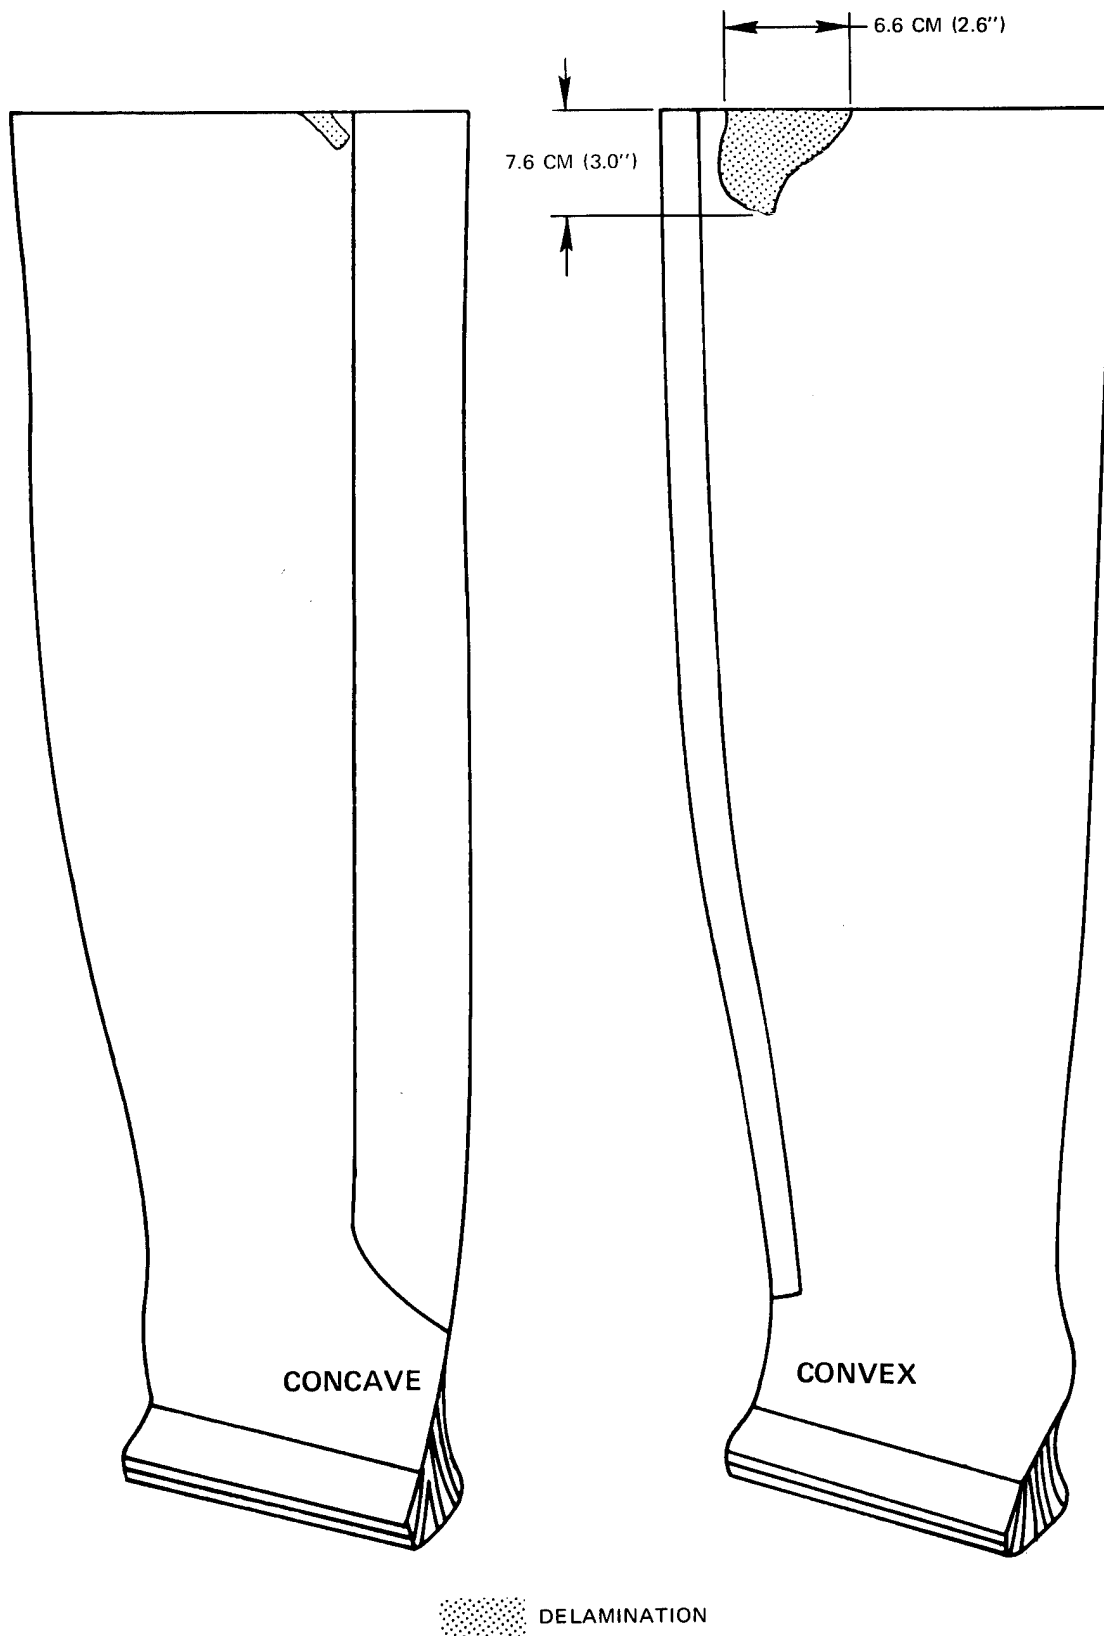
Figure 52 Visual Damage to Graphite/Epoxy Blade C-5 Following Impact with Starling

The visually delaminated area of C-5 shown in Figure 52, which also corresponds to post-test ultrasonic indications, is in a location where a pre-test ultrasonic indication was present. The starling impact caused this area of delamination to grow. If the blade had been well consolidated in this area, possibly no damage would have occurred from the impact.

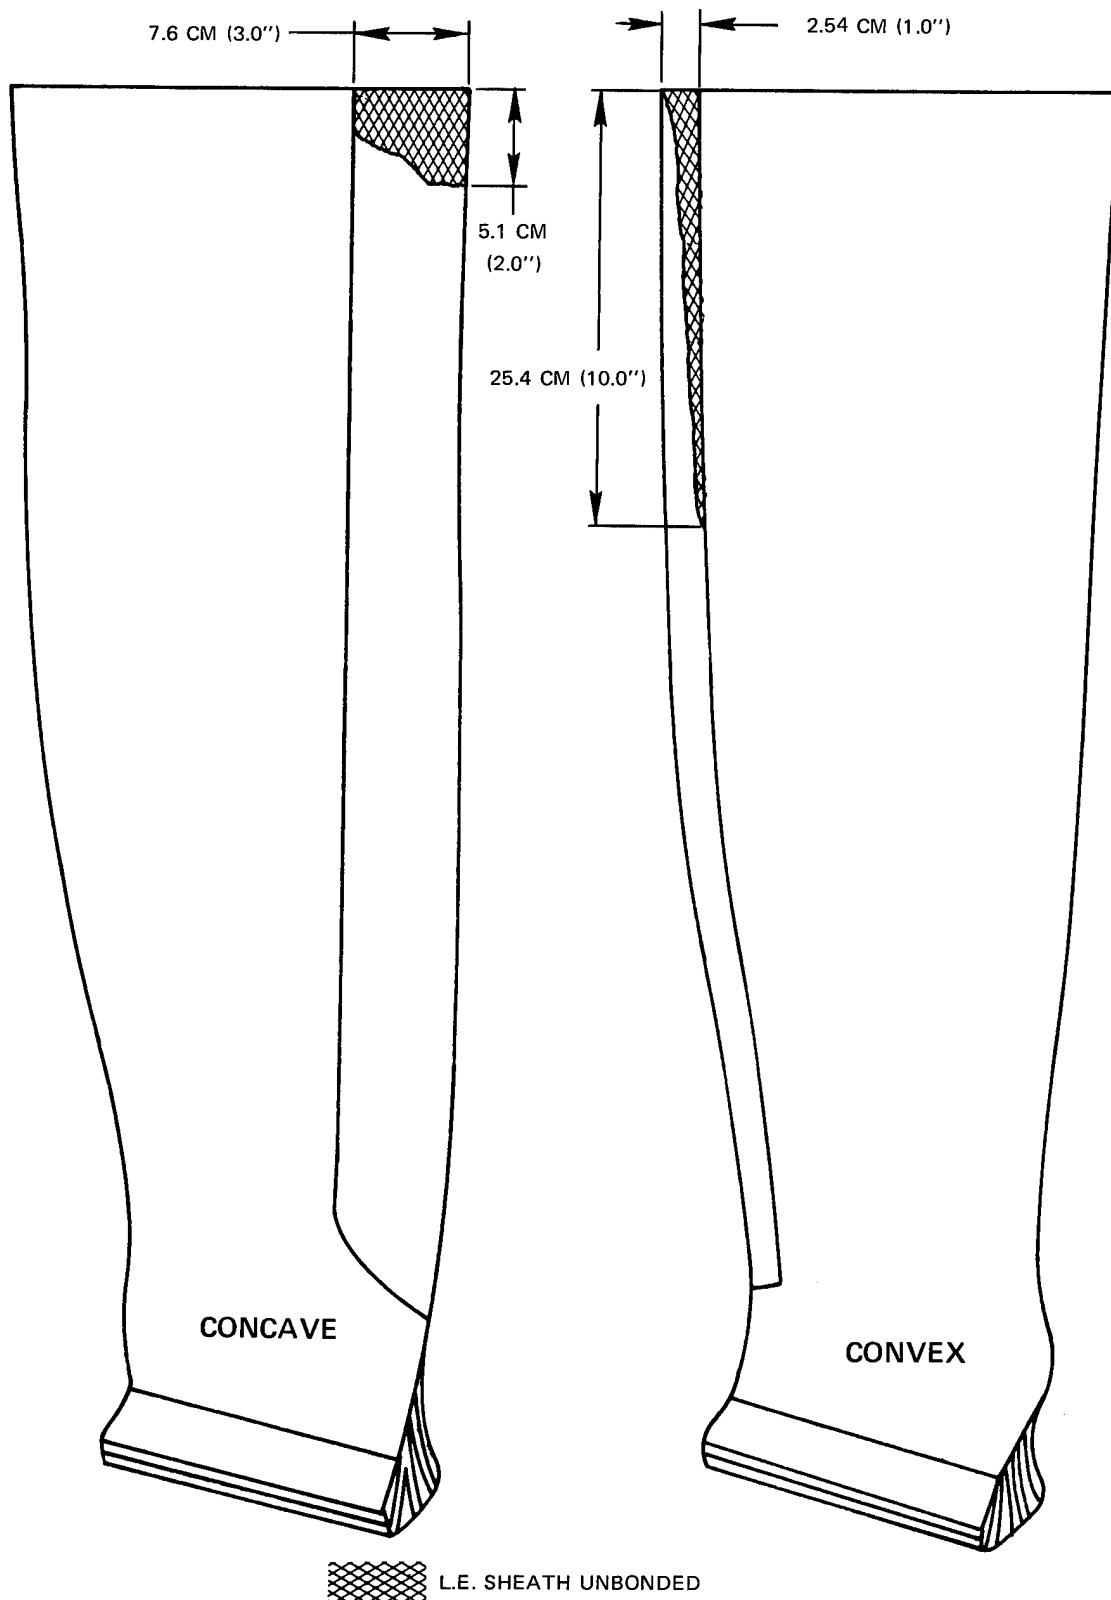
Figure 53 Visual Damage to Boron/Epoxy Blade B-5 Following Impact with Starling

Only a small amount of leading-edge sheath unbonding, as shown in Figure 53, resulted from B-5 starling impact. Better bonding of the sheath to the blade could perhaps prevent such damage. No post-test ultrasonic indications were found on this blade.

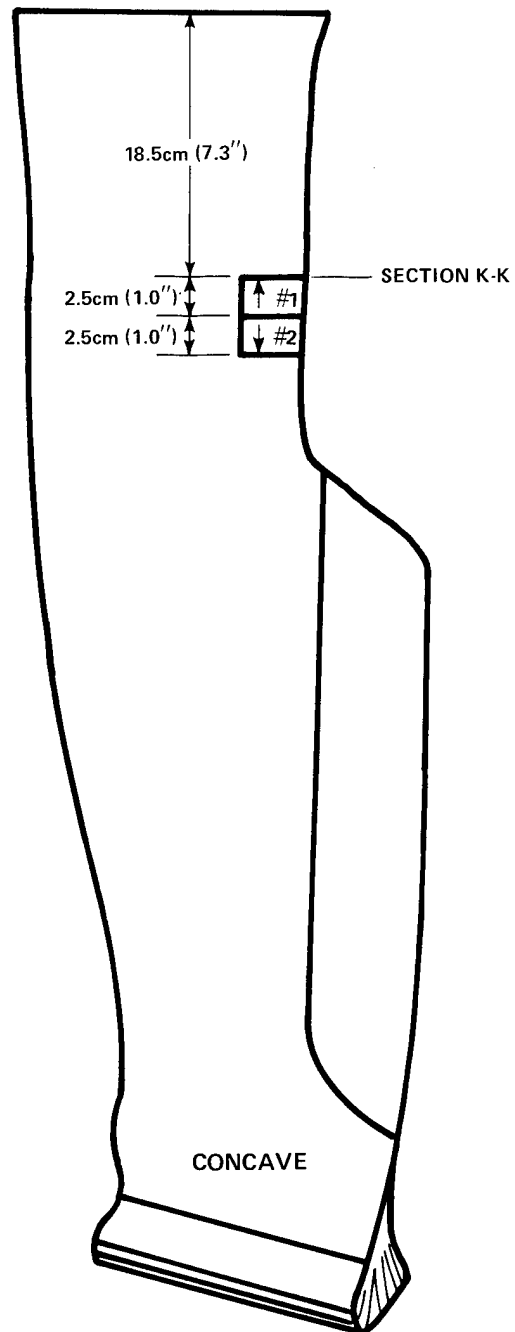
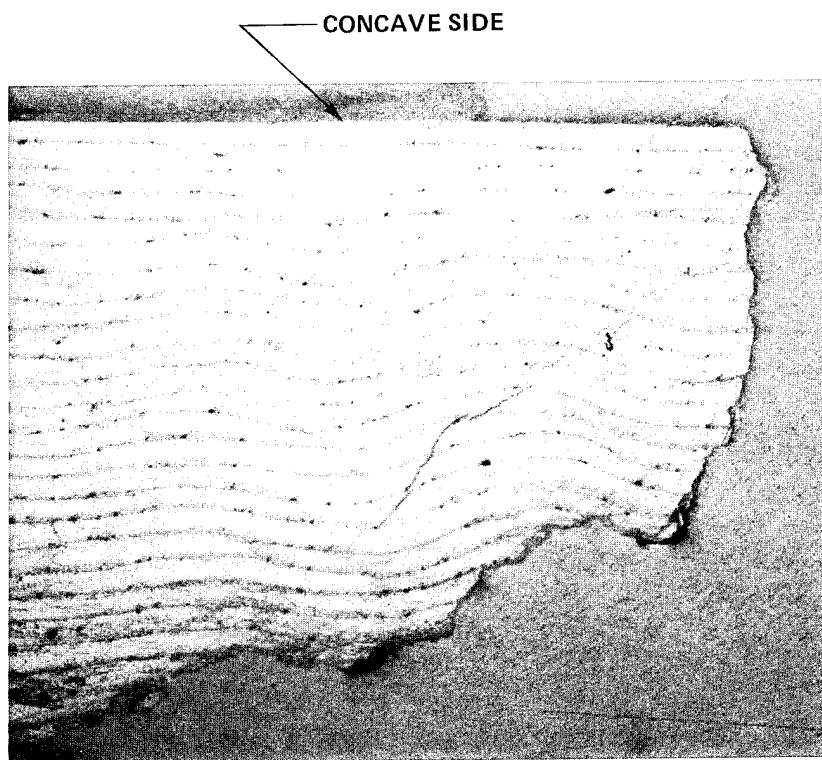
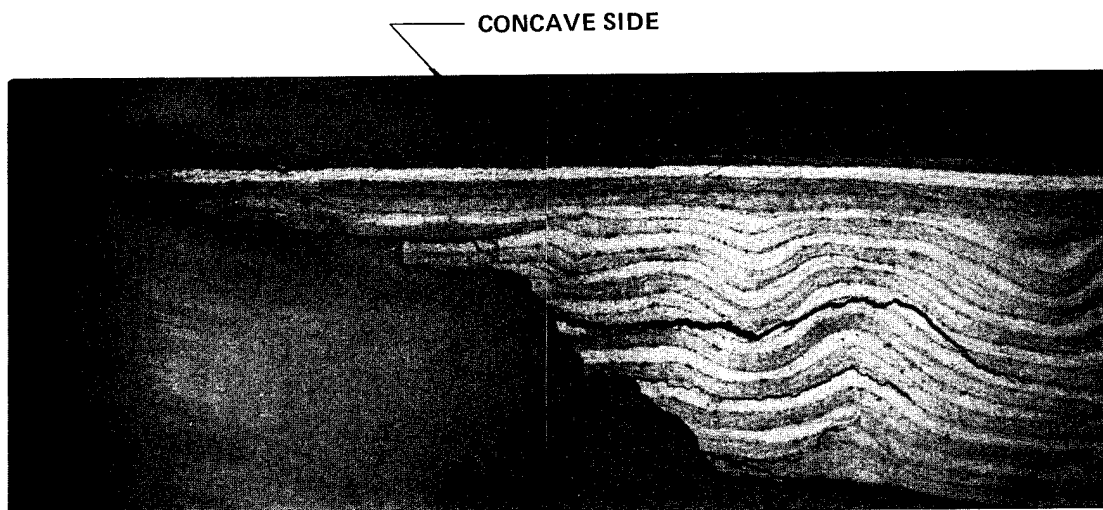
Figure 54 Metallographic Section Locations - Graphite/Epoxy Blade C-3

Graphite/epoxy blade C-3 was sectioned in the area of the impact damage for metallographic study. Two chordwise sections were examined, as illustrated in Figure 54. Section 1 revealed a shear crack of approximately .41 cm (.16 in) length angled at 40° from the concave blade surface as shown in Figure 55. Section 2, pictured in Figure 56, revealed five interlaminar separations which propagated for a length of .10 cm (.04 in) to .66 cm (.26 in) in the chordwise direction. No internal composite damage was found further away from the broken area of the blade.
